Manhole Inspection Summary

Manhole # S290__048MH

Insp Date: 11/17/08 11:38 AM

Location Address: **1118 S Paca St**

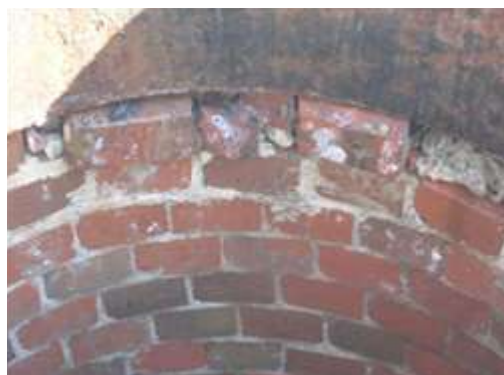
Defect 4

Condition: ☐ Sound ☐ Cracked ☐ Root Intrusion ☒ **Loose Brick** ☒ **Deteriorated**

Infiltration: ☐ None ☒ **Joint** ☐ Cracks ☐ Mortar ☐ Roots ☐ Wall

deteriorated chimney, signs of infiltration

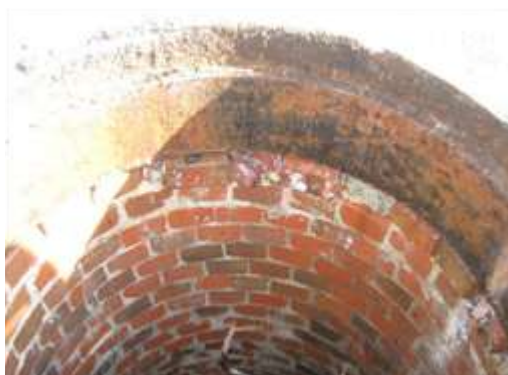
Defect 3

loose bricks under chimney

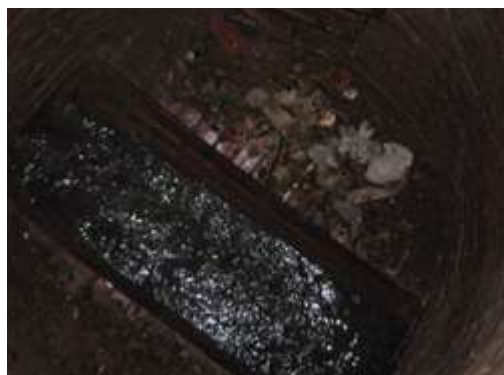
Defect 2

Condition: ☐ Sound ☐ Cracked ☐ Root Intrusion ☐ Deteriorated ☐ Leaks ☒ **Debris**

debris on bench

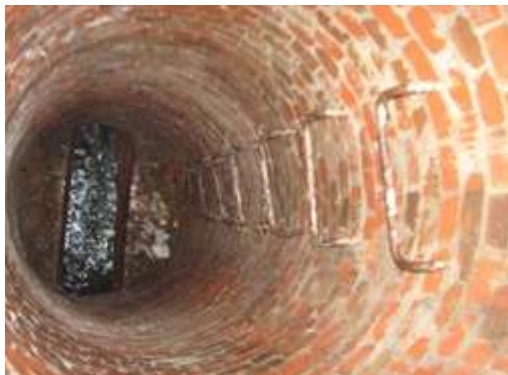
Defect 1

Infiltration: ☐ None ☐ Joint ☐ Cracks ☐ Mortar ☐ Roots ☒ **Wall**

Steps Count: **11** Missing: **0** ☒ **Corroded**

signs of corbel infiltration, corroded rungs

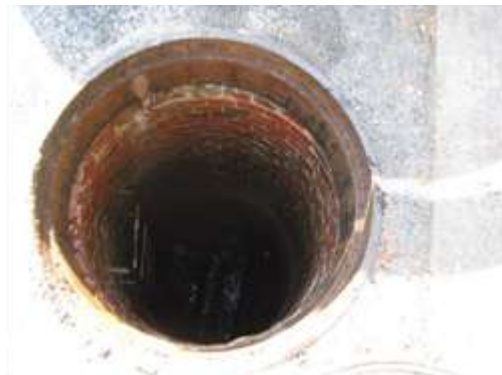
Defect 5

Frame Offset: **0** (in.) Condition: ☐ Sound ☐ Cracked ☒ **Leaks**

Frame leaks
